RY ANALYSIS DIVISION		
over str	Rao Hwy. Bridge SE No. 1 eam o. 28 on NE 48-2	COUNTRY  North Vietnam	COORDINATES  19 17N - 104 26E  VG 402320	 25X1
MAP	AMS L509 NE 48-2		BRIEF NO: PIB 75001 July 1966	 25X1
LOCATION:	0.5 nm S of Cua Rao on Ro	ute 7.		
LENGTH WIDTH Type	Deck	MATERIAL Concrete NO. OF SPANS 3 probe	able	25X1 25X1

CIA IA	MAGERY ANALYSIS DIVISION		<del></del>
NAME		COUNTRY	COORDINATES	
Phuong Hoang Hwy. Bridge No. 66 on 1		North Vietnam	18 13N - 106 04E XF 136146	
			BRIEF NO: PIB 75002	 25X
MAP AMS L50	9 NE 48-7		<b>T</b> July 1966	
LOCATION: 0.5 nm	N of Phuong Ho	ang on Route 1A.

CIA IMAGE	RY ANALYSIS DIVISION		
NAME Quang Te RR. Bridge over Khe Hac Giang Bridge No. 30 on NE 48-7	COUNTRY  North Vietnam	COORDINATES  18 27N - 105 34E  WF 609405	 25X1 
MAP AMS L509 NE 48-7		BRIEF NO: PIB 75003 July 1966	25X1

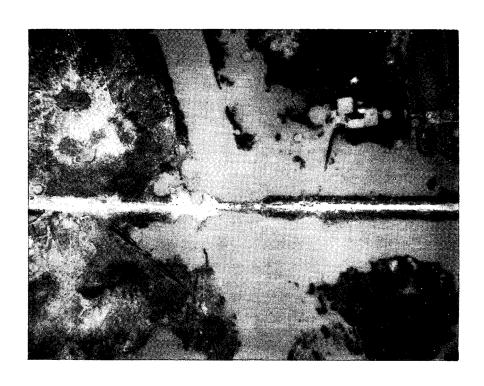
2 spans heavily damaged; piers and abutments intact.

Repairs underway.

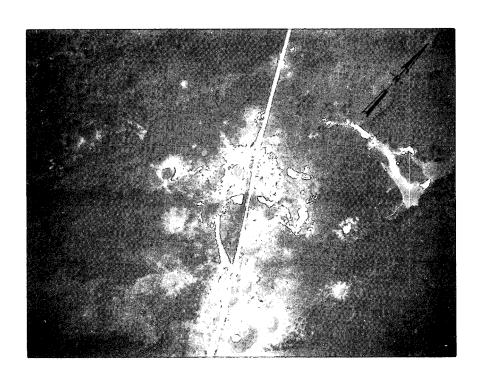
Span repaired; bridge serviceable.

Ford.

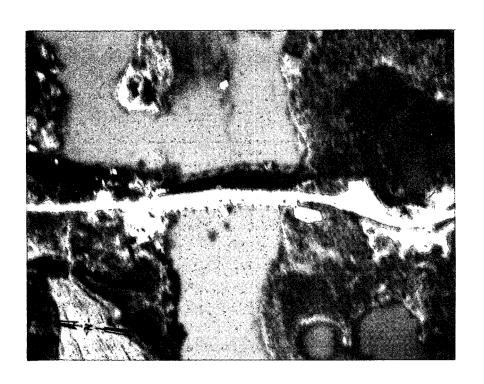
CIA IMAGER	RY ANALYSIS DIVISION		
ridge No. 7 on NF 48-10	COUNTRY North Vietnam	COORDINATES 21 20N - 103 54E UJ 873606	
MAP .AMS L509 NF 48-10		#RIEF NO: PIB 75035 August 1966	
LOCATION: 0.5 nm SE of Ban Lan on Ro	ute 6.		
DESCRIPTION:  LENGTH WIDTH TYPE  Deck  STATUS:  Bridge repaired and serviceable	MATERIAL Timber and NO. OF SPANS 2 LENGTH OF EACH SPAN	concrete	
COMPENSATIVE ACTION:			
None			
		et e

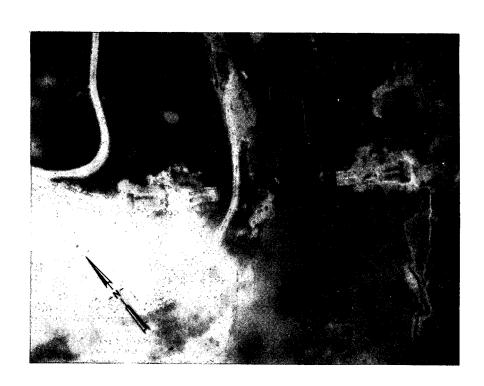
CIA IMAGER	RY ANALYSIS DIVISION		_
over Nam Quat  Bridge No. 17 on NE 48-11	COUNTRY  North Vietnam	COORDINATES   17 57N = 105 49E   WE 861859	<b>-</b> 25X
MAP AMS L509 NE 48-11  LOCATION: 0.8 nm NW of Xom Ca Trang	on Pouto 15	BRIEF NO: PIB 75036 August 1966	- 25X -
DESCRIPTION:  LENGTH 190' approx.  WIDTH  TYPE  Deck	MATERIAL Concrete and		25X
STATUS:  Bridge repaired - destroyed spa	ns replaced by cables	and removable decking.	
COMPENSATIVE ACTION: Ford			
			25X

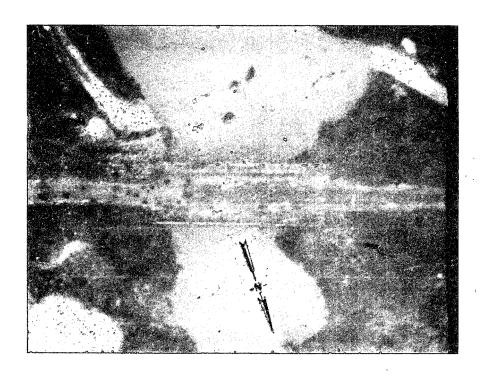
CIA IMA	AGERY ANALYSIS DIVISION		
NAME	COUNTRY	COORDINATES	
Ban Lac Hwy. Bridge		21 19N - 103 55E	
Bridge No. 6 on NF 48-10	North Vietnam	UJ 876584	ocusan
		BRIEF NO:	25×
		PIB 75054	23/
MAP AMS L509 NF 48-10		July 1966	
LOCATION: 0.5 nm W of Ban Lac on	Route 6.		
DESCRIPTION:			
	MATERIAL Concrete	e and wood	
LENGTH 40' approx.	NO. OF SPANS	e and wood	
Deck	LENGTH OF EACH SPAN	20' approx	25X
Deck		zo approx.	
STATUS:			
Repaired and serviceable.			
<b>-</b>			
COMPENSATIVE ACTION:			
None			
			25>

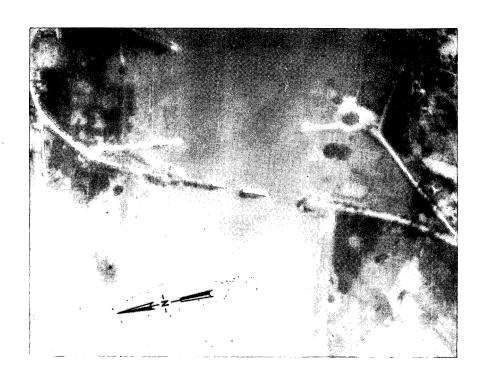
CIA IMAGE	RY ANALYSIS DIVISION	
NAME Thanh Yen Hwy. Bridge over Raoda Bridge No. 2 on NE 48-12	COUNTRY  North Vietnam	COORDINATES
MAP AMS L509 NE 48-12 LOCATION: 0.5 nm S of Thanh Yen on 1	Route LA.	BRIEF NO: 25X PIB 75066 August 1966
DESCRIPTION:  LENGTH WIDTH TYPE  Deck and half-through true	NO. OF SPANS 8 (6 cond	d concrete 25X crete deck, 2 steel truss) 25X
5 concrete, deck-spans destroyed destroyed.	d; 2 steel truss spans	damaged, 3 piers
COMPENSATIVE ACTION:		
Ford		
		25X

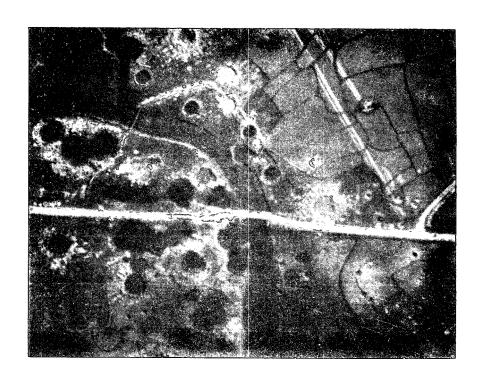
3 spans destroyed, 2 piers damaged.

Rockfill causeway and temporary timber span approximately 15' in length.

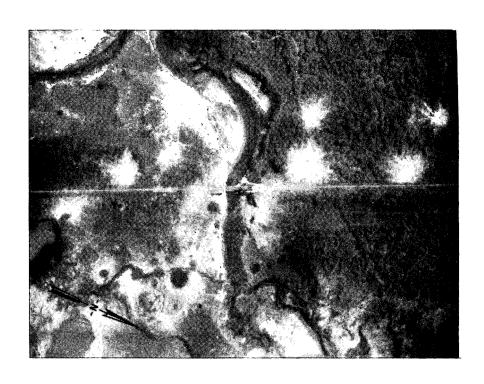
RY ANALYSIS DIVISION		
Khe Ac	Trach RR. Bridge over	COUNTRY  North Vietnam	18 08N - 105 44E WF 781050	 25X
MAP	AMS L509 NE 48-7		BRIEF NO: PIB 75080 August 1966	 25X
LOCATION:	1.5 nm NW of Phuc Trach of	on Vinh/Dong Hoi Rail	Line.	
DESCRIPTION	l:			
LENGTH WIDTH Type	40' approx. Single track Deck	material Steel and no. of spans 1 length of each span 1	d concrete 40' approx.	25X
status: Spai	n repaired, bridge now serv	viceable.

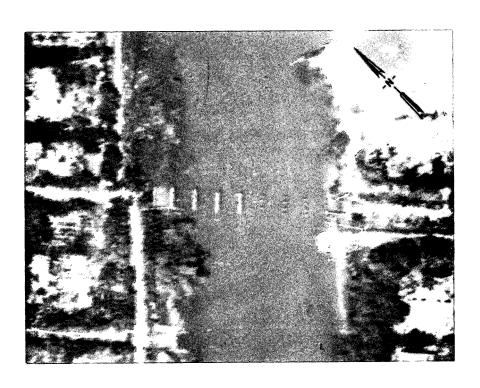
CIA IM	AGERY ANALYSIS DIVISION		
NAME	COUNTRY	COORDINATES	<del></del>
Uan Ao Hwy. Bridge		17 12N - 106 48E	
Bridge No. 29 on NE 48-12	North Vietnam	XE 918039	
		BRIEF NO:	 25X
		PIB 75103	23/
MAP JOG (A) 1501 NE 48-12		August 1966	
LOCATION: 0.7 nm NW of Uan Ao on	an unnumbered route.		
DESCRIPTION:			
LENGTH	MATERIAL Timber		25X
WIDTH	NO. OF SPANS 9 appr	OX.	25/
TYPE L Deck	LENGTH OF EACH SPAN		25X
	L		
STATUS:			
8 spans destroyed; 4 piers	moderately damaged.		
COMPENSATIVE ACTION:			
Ferry			
			25X

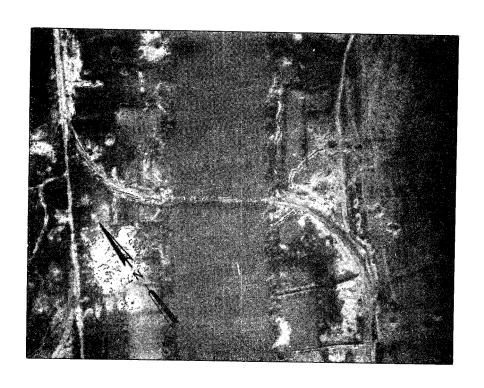
RY ANALYSIS DIVISION		
over Song Hoang Mai  Bridge No. 1 on NE 48-3	COUNTRY  North Vietnam	COORDINATES 19 15N - 105 41E WG 720302	 25X1
MAP AMS L509 NE 48-7 LOCATION: 0.4 nm W of Qui Vinh on t	he Hanoi-Vinh Rail Lind	BRIEF NO: PIB 75126 August 1966	25X1
DESCRIPTION:  LENGTH WIDTH TYPE  Wood trestle  STATUS:	MATERIAL Timber k) no. of spans 16 approx LENGTH OF EACH SPAN	X.	25X1 25X1
Repaired and serviceable.  COMPENSATIVE ACTION:  By-pass No. 1 remains serviceal	ble.		
			25X1

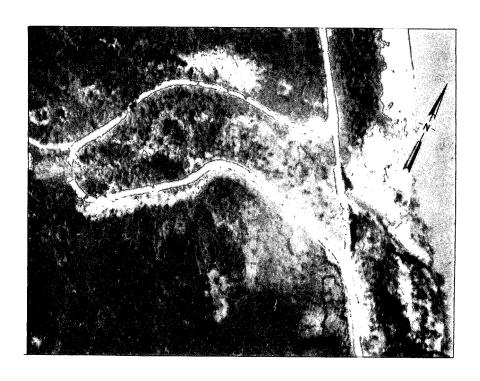
Approved For Release 200	CONFIDENTIAL	51A001600050001-7	ILLE
	GERY ANALYSIS DIVISION		
stream Bridge No. 15 on NE 48-2	North Vietnam	COORDINATES  19 17N - 104 20E  VG 305334	25>
MAP AMS JOG (A) 1501 NE 48		PIB 75130 August 1966	<del></del> 25>
DESCRIPTION: 1 nm SE of Ban Ta Xa on	Route 7.		
LENGTH WIDTH TYPE Deck	MATERIAL Concrete NO. OF SPANS 3 LENGTH OF EACH SPAN	and wood	25) 25)
Center span dropped; one end	span heavily damaged.		
COMPENSATIVE ACTION:			
Ford.			
			25)

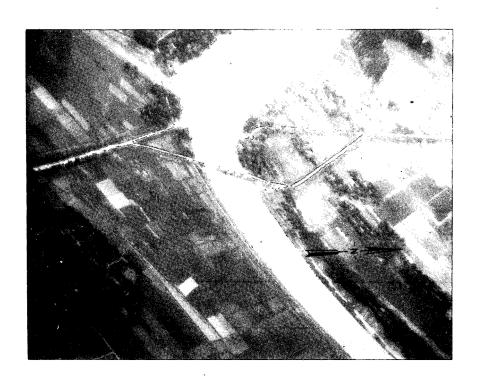
CIA IMAGER	RY ANALYSIS DIVISION		
NAME Tri Dong Hwy. Bridge over Song	COUNTRY	COORDINATES	<del></del>
Day Bridge No. 2 on NF 48-15	North Vietnam	20 21N - 105 55E WH 966517	25X
MAP AMS 1509 NF 48-15		BRIEF NO: PIB 75135 August 1966	25X
LOCATION: 0.2 nm E of Tri Dong on Ro	oute 1A.		
DESCRIPTION:			
width type  Deck	material Concrete no. of spans 8 length of each span	30' approx.	25×
STATUS: Repaired and serviceable.			
COMPENSATIVE ACTION:			
NA

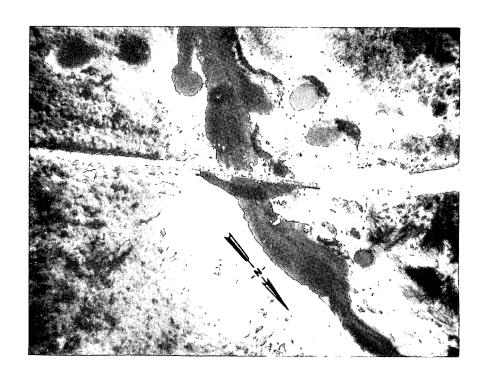
CIA IMAGEF	RY ANALYSIS DIVISION		
NAME Lang Khav RR. Bridge over	COUNTRY	COORDINATES	- 2
Ngoi Kay	]	22 OlN - 104 31E	
Bridge No. 8 on NF 48-6	North Vietnam	VK 509359	2
		BRIEF NO:	•
		PIB 75152	
MAP AMS L509 NF 48-6		September 1966	
-ocation: 1.8 nm SW of Ky Dong on Har	noi-Lao Cai Rail Line	•	•
DESCRIPTION:			
	Minub are and	3 -4 3	
winth 135' approx.	MATERIAL Timber and	i steel	2
TYPE (Single track)	NO. OF SPANS 3	1 8 001	
Deck	•	L @ 90' approx., 1 @ 30'	app
	-	L @ 15' approx.	
TATUS:		L @ 15' approx.	
TATUS: Repaired and serviceable.		L @ 15' approx.	
		L @ 15' approx.	
Repaired and serviceable.	•	L @ 15' approx.	
Repaired and serviceable.	•	L @ 15' approx.	
Repaired and serviceable.		L @ 15' approx.	
Repaired and serviceable.	•	L @ 15' approx.	2

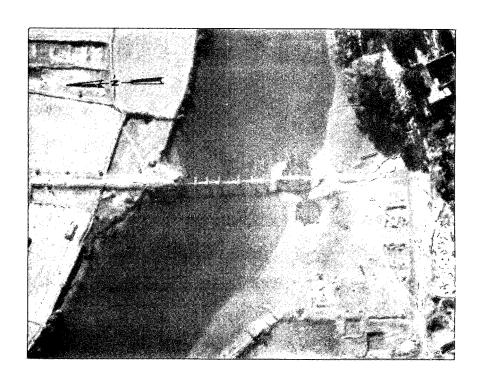
CIA IMA	AGERY ANALYSIS DIVISION		
NAME	COUNTRY	COORDINATES	
Vinh Loc Hwy. Bridge Bridge No. 30 on NE 48-11	North Vietnam	17 43N - 106 23E XE 468608	
		BRIEF NO: PIB 75156	<del>—</del> 25Х
MAP AMS L509 NE 48-11		September 1966	_0, (
LOCATION: At Vinh Loc on an unnum	bered route.		<del></del>
DESCRIPTION:	m		
LENGTH Width	material Timber no.of spans 12 <b>–</b>		25X
Deck	LENGTH OF EACH SPAN		25X
STATUS: Repaired and serviceable to	foot traffic.		
COMPENSATIVE ACTION:			
AM			
			25X

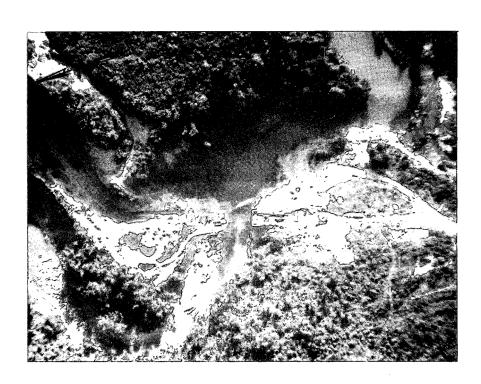
AGERY ANALYSIS DIVISION		<del></del>
N AME	COUNTRY	COORDINATES	
Ban Pa Ang Hwy. Bridge		21 34N - 103 16E	
Bridge No. 16 on NF 48-9	North Vietnam	UJ 205855	
	-	BRIEF NO:	_
		PIB 75172	25X
MAP AMS L509 NF 48-9		September 1966	
LOCATION: 0.2 nm SE of Ban Pa Ang	g on Route 19.	<u> </u>	
	·	•	
DESCRIPTION:			
LENGTH 70' approx.	material Steel an	d concrete	
WIDTH	no. of spans $\ \ \ \ \ \ \ \ \ \ \ \ \ \ \ \ \ \ \$		
Half-through truss	LENGTH OF EACH SPAN	70' approx.	25X
_			
STATUS:			
Span is destroyed; 1 abutme	ent heavily damaged; br	idge has been replaced	
by a 70' approx. single-spa	an cable bridge utilizi	ng 6 cables and removable	е
decking.	_		
COMPENSATIVE ACTION:			
Ford			
			25X

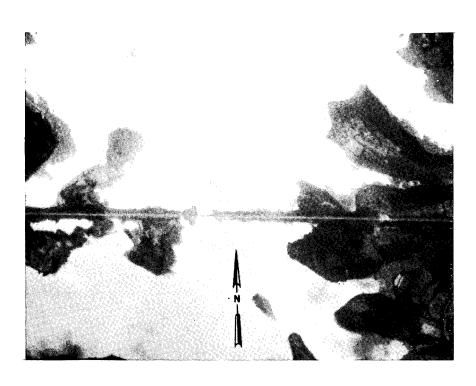
NAME	COUNTRY	COORDINATES	—
Chien Ung RR. Bridge		21 24N - 105 10E	
Bridge No. 13 on NF 48-11	North Vietnam	WJ 183669	
MAP JOG (A) 1501 NF 48-11		PIB 75180 September 1966	2
LOCATION: 0.4 nm E of Chien Ung or	n Hanoi/Lao Cai Rail I		
DESCRIPTION:  LENGTH 90' approx.	MATERIAL Concrete		
width type  Deck  Single trace		rmined	2
STATUS: Repaired and serviceable.			
COMPENSATIVE ACTION:			
NA			
			2
